4.3.9.1 Unit Type WH.2.W Wherry 2400 Housing

Base Name: Holloman Air Force Base

4.3.9.2 Unit Type WH.2.X Wherry 2400 Housing

4.3.2.1 Unit Type CP.4.G 2710 San Juan Loop Holloman AFB, New Mexico

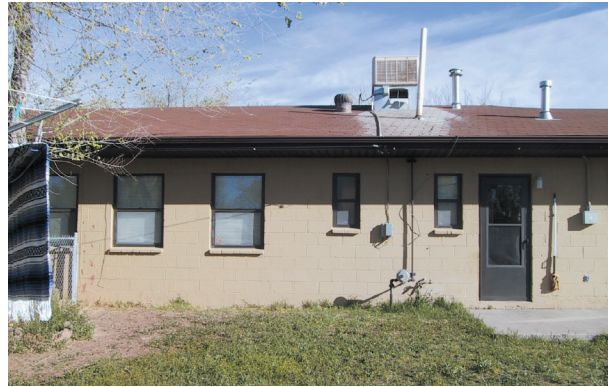
Rear elevation

- Exterior Wall Structure: concrete masonry unit; fair condition; concrete lock walls do not provide proper insulating value for exterior walls; some noted minor cracking of block.
- Exterior Wall Covering: painted; fair condition; painted concrete block provides poor appearance; maintenance issue.
- Foundation/Basement: slab on grade; good condition; some minor slab settlement.
- Floor Structure: none; slab on grade.
- Windows - Frames: aluminum; good condition.
- Windows - Glazing: double; good condition; bedroom windows provide emergency egress.
- Windows - Screens: aluminum; good condition.
- Doors - Entry: wood; fair condition; flush door with many coats of paint.
- Doors - Sliding Glass: none; not required.
- Doors - Storm/Screen: aluminum; good condition.
- Doors - Hardware: brass; fair condition; worn finish.

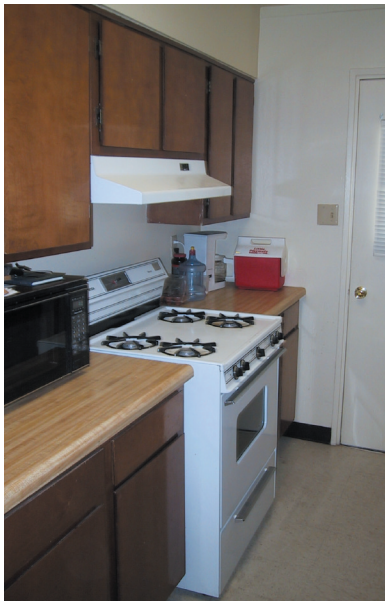
Kitchen

- Cabinets: wood; fair condition; worn finishes.
- Counter Tops: laminated; fair condition; worn finish; some staining.
- Sink: stainless sink, double; fair condition; slightly worn finish.
- Sink Fixtures: metal; fair condition; worn finish.
- Refrigerator: standard; fair condition; worn interior.
- Range/Oven: gas; fair condition; older unit.
- Vent Hood: exhaust fan; fair condition; older unit.
- Dishwasher: standard; fair condition; older heating element.
- Garbage Disposal: standard; fair condition; older unit.
- Flooring: vinyl composition tile; fair condition; slightly worn.
- Walls: gypsum wall board; fair condition; uneven.
- Wall Finish: painted; fair condition; slightly worn; textured finish.
- Ceilings: gypsum wall board; fair condition; worn.
- Ceiling Finish: painted; fair condition; slightly worn.
- Interior Hardware: none; not required.

- Cabinets: refinish wood cabinets.
- Counter Tops: install new counter top.
- Sink: install new stainless steel sink.
- Sink Fixtures: install new sink fixtures.
- Refrigerator: install new refrigerator.
- Range/Oven: install new range/oven.
- Vent Hood: install new vent hood.
- Dishwasher: install new dishwasher.
- Garbage Disposal: install new garbage disposal.
- Flooring: install new ceramic tile floor.
- Walls: replace gypsum wall board.
- Wall Finish: paint gypsum wall board.
- Ceiling: replace gypsum board ceilings.
- Ceiling Finish: paint gypsum board.

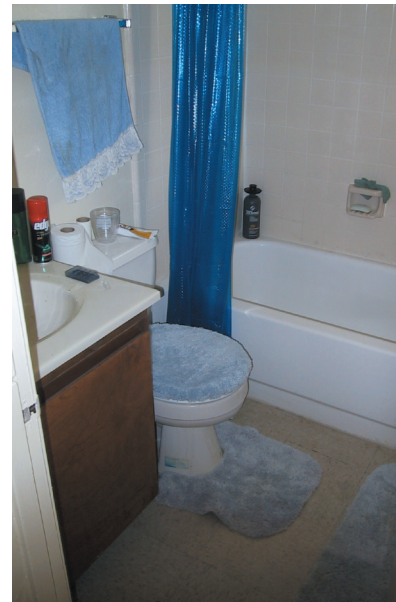
Bathroom 1

- Cabinets: wood; poor condition; worn finish; not attractive dark stain.
- Counters: cultured marble; good condition.
- Sink: cultured marble; good condition.
- Fixture Hardware: metal; fair condition; worn finish.
- Toilet: porcelain; fair condition; worn, older.
- Tub/Shower: combination; fair condition; tile enclosure; no slip resistance in tub; slight wear of ceramic tile joints.
- Flooring: vinyl composition tile; poor condition; loose tiles.
- Walls: gypsum wall board; good condition.
- Wall Finish: painted; good condition.
- Ceilings: gypsum wall board; good condition.
- Ceiling Finish: painted; good condition.
- Ventilation: window over tub/shower; no exhaust fan.
- Interior Hardware: metal; fair condition; worn finish.

- Cabinets: install new wood vanity cabinet with cultured marble top.
- Fixture Hardware: install new hardware.
- Toilet: replace toilet.
- Tub/Shower: install new tub with ceramic tile enclosure; fill in existing window in tub/shower.
- Flooring: install new ceramic tile floor.
- Ventilation: install new exhaust fan.
- Interior Hardware: install new hardware.

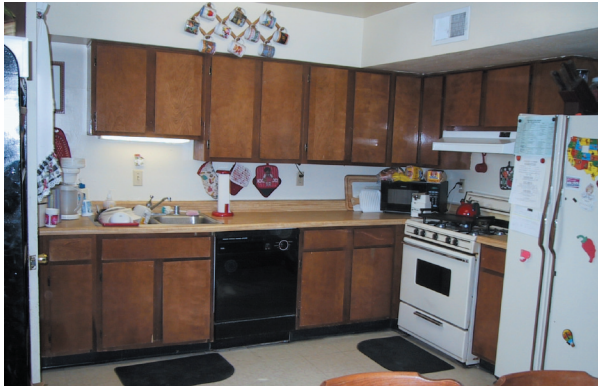
Kitchen

- Cabinets: wood; fair condition; cabinet finish and interiors are worn.
- Counter Tops: laminated; fair condition; dated butcher block pattern.
- Sink: stainless sink, double; fair condition; finish has dulled.
- Sink Fixtures: metal; fair condition; slightly corroded.
- Refrigerator: two-door; good condition.
- Range/Oven: gas; fair condition; slightly worn.
- Vent Hood: exhaust fan; fair condition.
- Dishwasher: standard; fair condition.
- Garbage Disposal: standard; fair condition.
- Flooring: vinyl composition tile; fair condition; few broken and uneven tile.
- Walls: gypsum wall board; fair condition; wall board seams are visible.

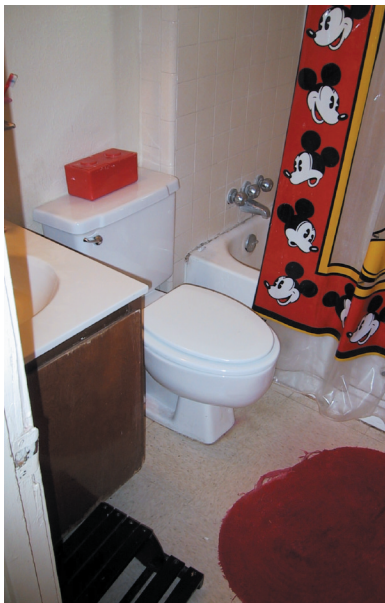
Bathroom 1

- Cabinets: wood; fair condition; worn finish and interior of cabinet.
- Counters: cultured marble; good condition.
- Sink: cultured marble; good condition.
- Fixture Hardware: metal; fair condition.
- Toilet: porcelain; fair condition.
- Tub/Shower: combination; fair condition; ceramic tile surround.
- Flooring: vinyl composition tile; fair condition; loose tile at tub due to water damage.
- Walls: gypsum wall board; fair condition; uneven.
- Wall Finish: painted; poor condition; paint is peeling.
- Ceilings: gypsum wall board; fair condition; uneven.
- Ceiling Finish: painted; poor condition; large patches of peeling paint hanging from ceiling.
- Ventilation: window; exhaust fan required.
- Interior Hardware: metal; fair condition; worn finish.

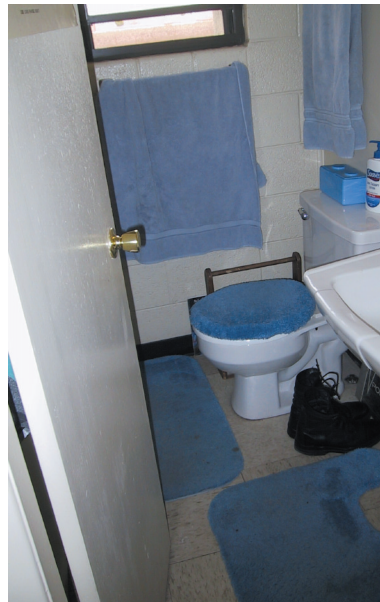
Bathroom 2

- Cabinets: none; wall mounted sink; does not meet AF standards.
- Counters: none; wall mounted sink; does not meet AF standards.
- Sink: wall mounted porcelain; fair condition; stained.
- Fixture Hardware: metal; fair condition; corroded.
- Toilet: porcelain; fair condition; stained.
- Tub/Shower: shower; fair condition; dated ceramic tile walls and flooring.

- Flooring: vinyl composition tile; poor condition; tile has been damaged at shower area.
- Walls: concrete masonry unit; fair condition; visible seam.
- Wall Finish: painted; fair condition; aged appearance.
- Ceilings: gypsum wall board; fair condition; visible seam.
- Ceiling Finish: painted; fair condition; aged appearance.
- Ventilation: exhaust fan; fair condition; dated fan.
- Interior Hardware: metal; fair condition; worn finish.

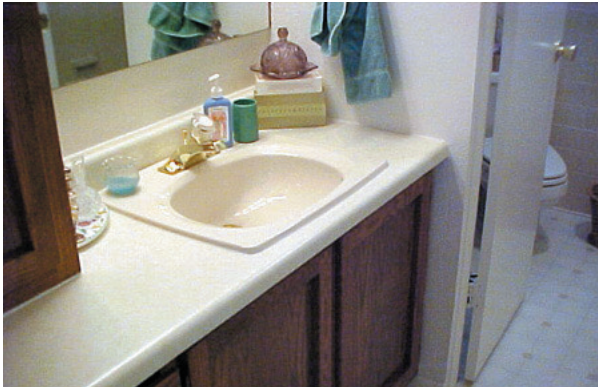
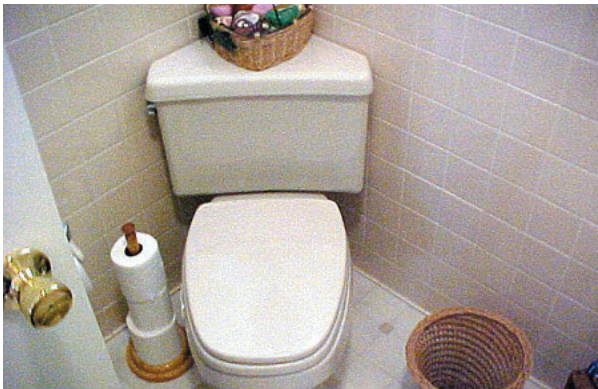
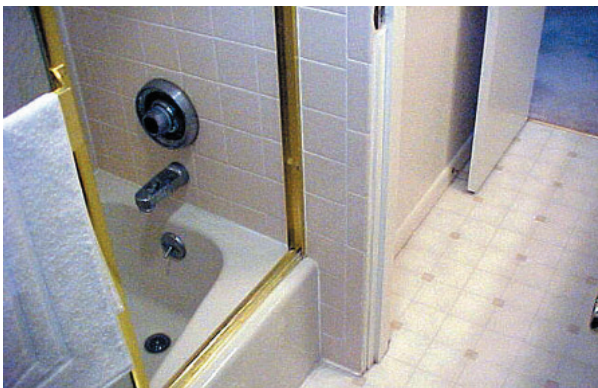
- Bathroom 2 serves Bedrooms 2, 3, and 4. It is separated into two areas by a swing door.
- The oak cabinet is in fair condition. An additional cabinet, mounted on the counter, is in fair condition.
- The plastic-laminate counter is in good condition.
- The enameled cast-iron, drop-in sink is in fair condition.
- The fixture hardware is in fair condition.
- The tank-type toilet is in good condition.
- The enameled cast-iron bathtub is in fair condition. The sliding acrylic shower doors are in fair condition. The ceramic tile shower surround is in good condition.
- The sheet vinyl flooring is in good condition.

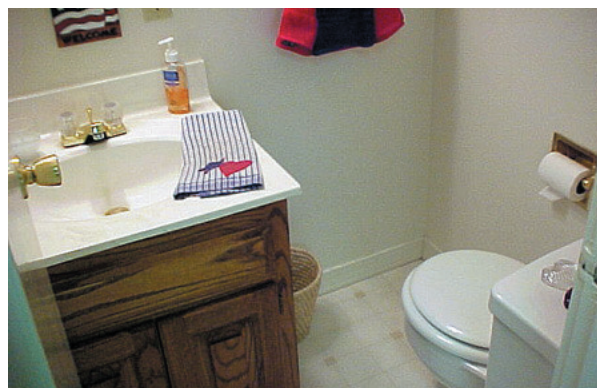
Bathroom 3

- The painted gypsum board walls and ceramic tile wainscoting are in good condition.
- The painted gypsum board ceiling is in good condition.
- Ventilation is through an operable window and a ceiling-mounted exhaust fan in good condition. Ventilation is adequate.
- The interior hardware is in fair condition.
